UNITED STATES ENVIRONMENTAL PROTECTION AGENCY

RE: Request for Information ("RFI") Pursuant to Section 308 of the Clean Water Act
Bergen Farms Concentrated Animal Feeding Operation (NYA000279)
Docket No. CWA-IR-14-024

Water Compliance Inspection Report

Inspection Date: May 6, 2014 Inspection Time: 0800 - 1600		Inspector: Christy Arvizu, Environmental Scientist USEPA Region 2, (212) 637-3961	
Weather Conditions: Partly Cloudy/Sunny, mid 50's			
Inspection Type: Compliance Evaluation Inspection			
On-Site Representatives: Michael Bergen, Partner, Bergen Farms, (607) 275 – 7115			
Other Attendees: Paul Murphy, Planner, Farm Compliance Services, (315) 427 – 4947; Nancy Rice, Environmental Engineer, NYSDEC Region 8, (585) 226 – 5453; Elaine Dalrymple, District Field Manager, Schuyler County Soil and Water Conservation District, (607) 535-0878; Kimberly McEathron, Physical Scientist, USEPA, Region 2, (212) 637-4228			
Bergen Farms Site Information:			
Main Farm 4060 Bergen Road Odessa, NY 14869	Glenview Farm 4715 Stewart Road Montour, NY 14845	Culver Road Farm Int. of Culver Road & McIntyre Road Hector, NY 14886	
NPDES/ICIS No.: NYA000279 SPDES General Permit No. GP-04-02

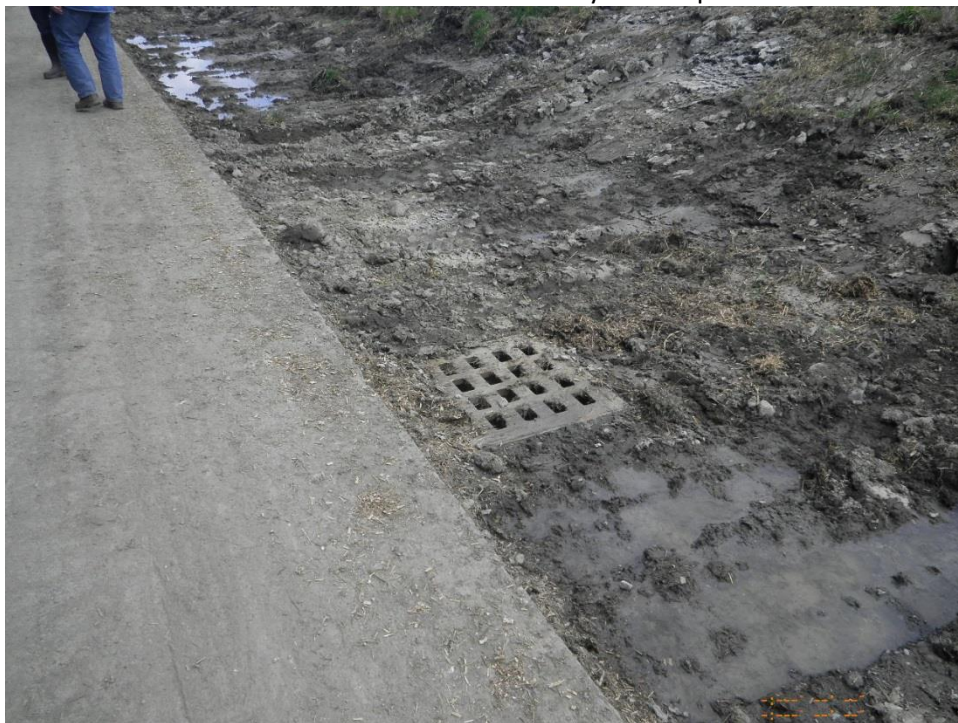
The inspection team observed catch basins to the east of Heifer Barn #1 that were not identified on the Facility’s farmstead map. Mr. Bergen stated that the catch basins connect to another catch basin by the shop which connects to the roadside ditch. The catch basin by the shop was also not identified on the Facility farmstead map.

Photo #1 – Catch basin to east of Heifer Barn #1; located adjacent to covered concrete feed alley way

6. During the inspection, the EPA inspection team observed that not all stormwater collection and clean water diversions were mapped on the Facility maps. Specifically, the EPA inspection team observed a catch basin to the east of the Heifer Barn that was not identified on the farmstead map, nor was a catch basin by the shop identified on the farmstead map. Nor were weekly stormwater inspections of all stormwater diversion structures, and devices channeling contaminated stormwater to the wastewater and manure storage and containment structures documented to show that they were done as required by Section IX.N.i of the NYSDEC CAFO General Permit.

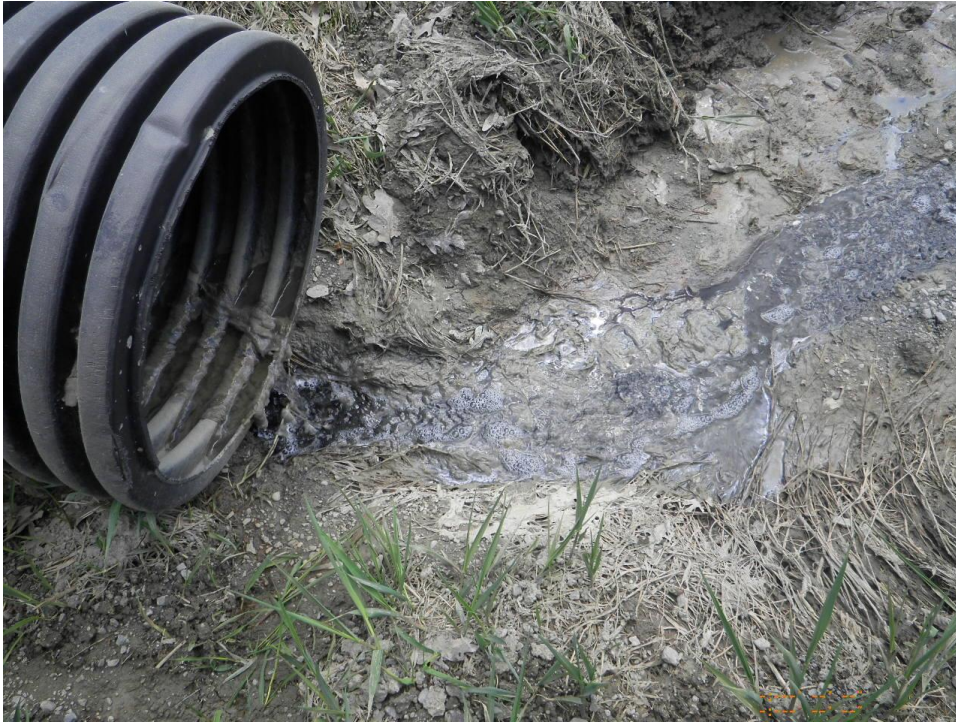
The inspection team observed a discharge from the underbunk drainage system via a large corrugated black pipe into a roadside ditch parallel to Bergen Road. The ditch went under Bergen Road and into a field ditch on the opposite side where it meandered along the borders of Field H6 and the field where the Vegetated Treatment Area (VTA) is located before discharging into a farm pond owned by the Facility. The farm pond then outlets into another field and ultimately discharges into the Upper Taughannock Creek just south of the intersection of Bergens Road and Havens Road (approximately 3,000 feet or just over half a mile from the farm pond). Prior to reaching the creek, the pond discharge picks up nutrients from an adjacent small dairy farm (non-CAFO) not owned by Mr. Bergen where cows have free access to the pasture (please see Attachment 1 for map).

The discharge from the underbunk drainage system into the roadside ditch consisted of gray water and had a strong silage leachate odor. EPA Inspector Arvizu walked along the roadside ditch to the point where it crossed under Bergen Road and noted that the color of the discharge was gray and the silage leachate odor still persisted.

Photo #2 – Discharge from underbunk drainage system at Main Farm; note gray water discharge and staining

- a. If corrective action for the underbunk drainage system cannot be completed **within thirty (30) calendar days of receipt of this RFI**, please provide a detailed explanation of what steps the Facility will take to address the issue. The description of planned steps should include a timeline for completion.

3. Section X.G of the NYSDEC CAFO General Permit requires the permittee to at all times properly operate and maintain all facilities and systems of treatment and control (and related appurtenances) which are installed or used by the permittee to achieve compliance with this permit. During the inspection, the EPA inspection team observed that the underbunk drainage system at the Main Farm was not being operated and maintained properly as there was a discharge of contaminated (non-clean) water from the drainage system. The contaminated water flowed to an on-site farm pond via a roadside ditch and field ditch before exiting the farm pond and making its way to the Upper Taughannock Creek and tributary approximately one half mile away. The EPA inspection team did note that the discharge from the pond flowed through an adjacent dairy farm where cows had free access to the pasture prior to entering the Upper Taughannock Creek.

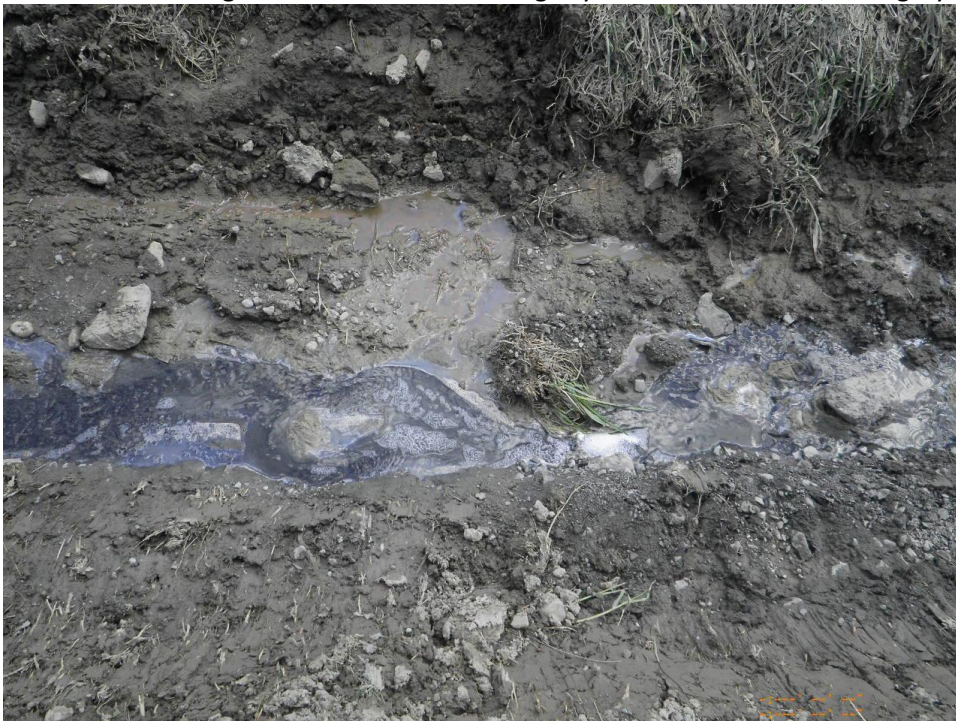
Photo #3 – Roadside ditch parallel to Bergen Road just before ditch goes underneath road; note gray water and foaming

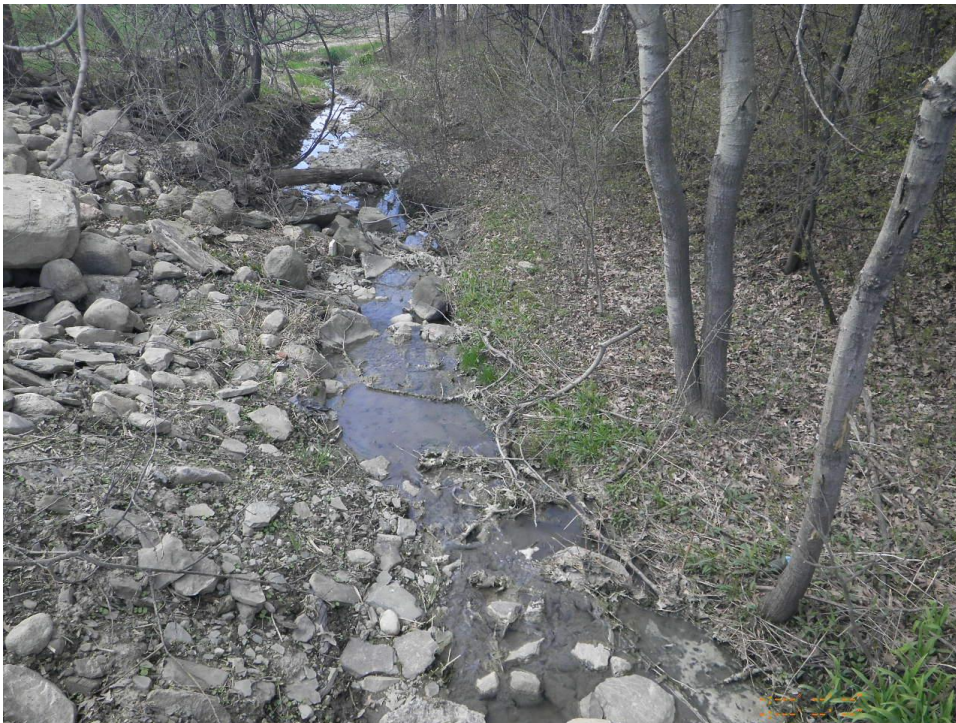
On the opposite (west) side of Bergen Road where the road side ditch discharged into a field ditch, the color of the discharge was still gray and the silage leachate odor was still present.

Photo #4 – West side of Bergen Road where roadside ditch discharges into field ditch

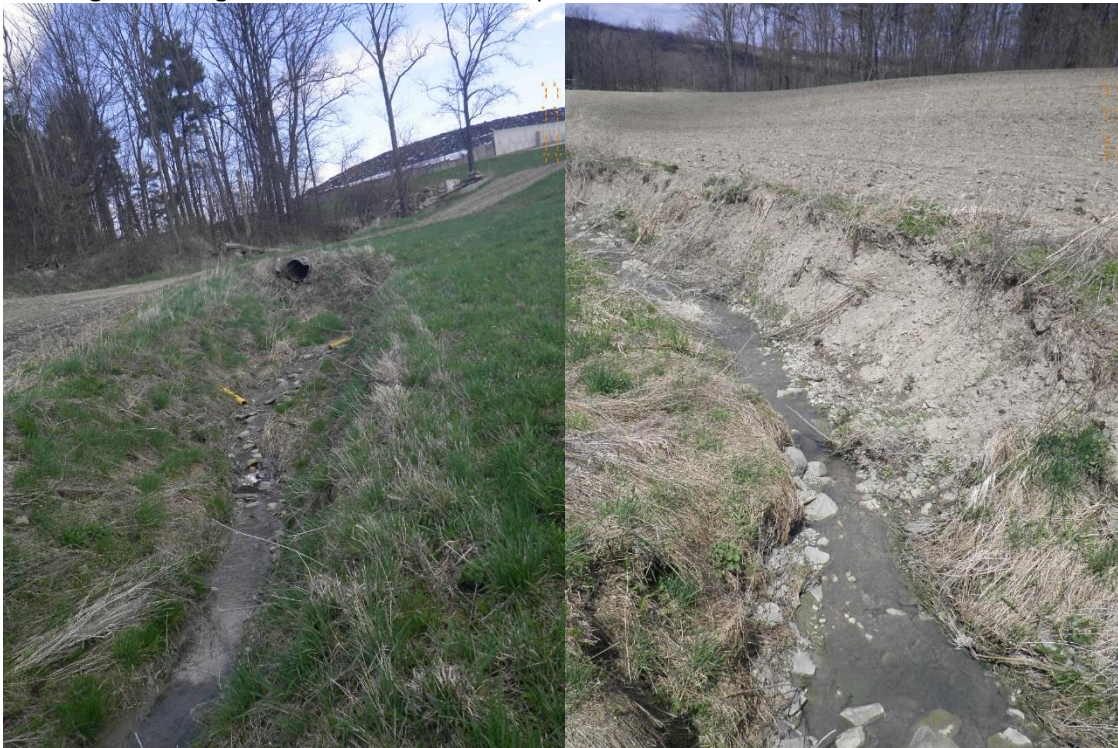
While observing the VTA which is immediately adjacent to the field ditch, EPA Inspector Arvizu noted that the gray discharge and silage leachate odor were still present.

Photos #5 & 6 – Field ditch connection; yellow pipes in photo on the left are tile lines

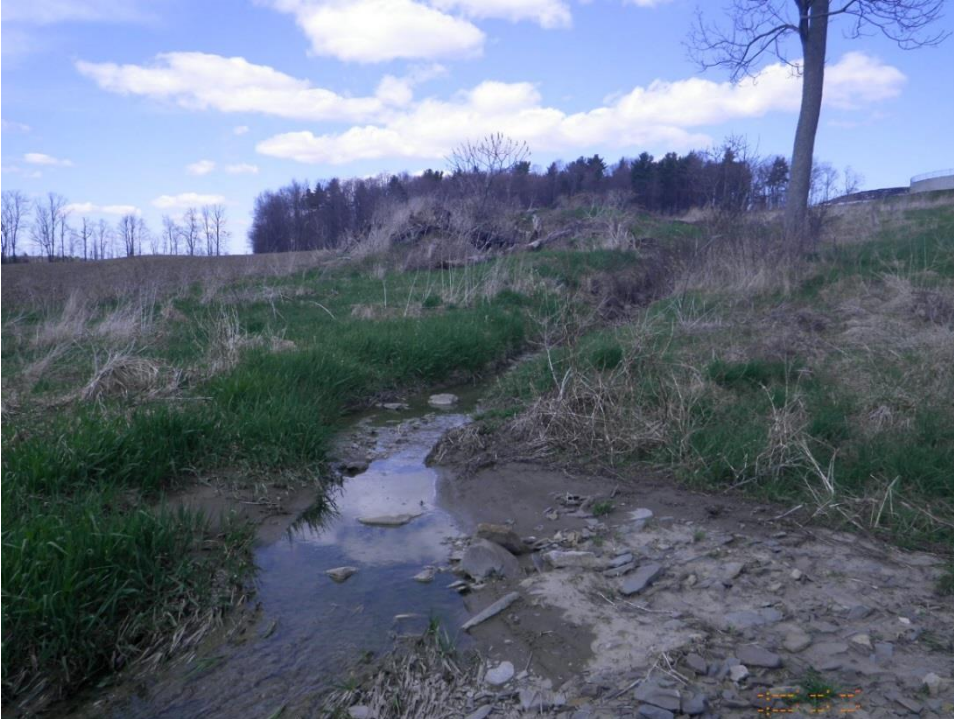
The field ditch connects to an on-site pond owned by the farm. At the point where the ditch connects to the pond, EPA Inspector Arvizu observed foaming, turbid water and noted the presence of a heavy silage leachate odor. Mr. Bergen stated that the pond received flow via the field ditches and the roadside ditch that is adjacent to the bunk

Photo #7 – Connection point between farm pond (foreground) and field ditch (background)

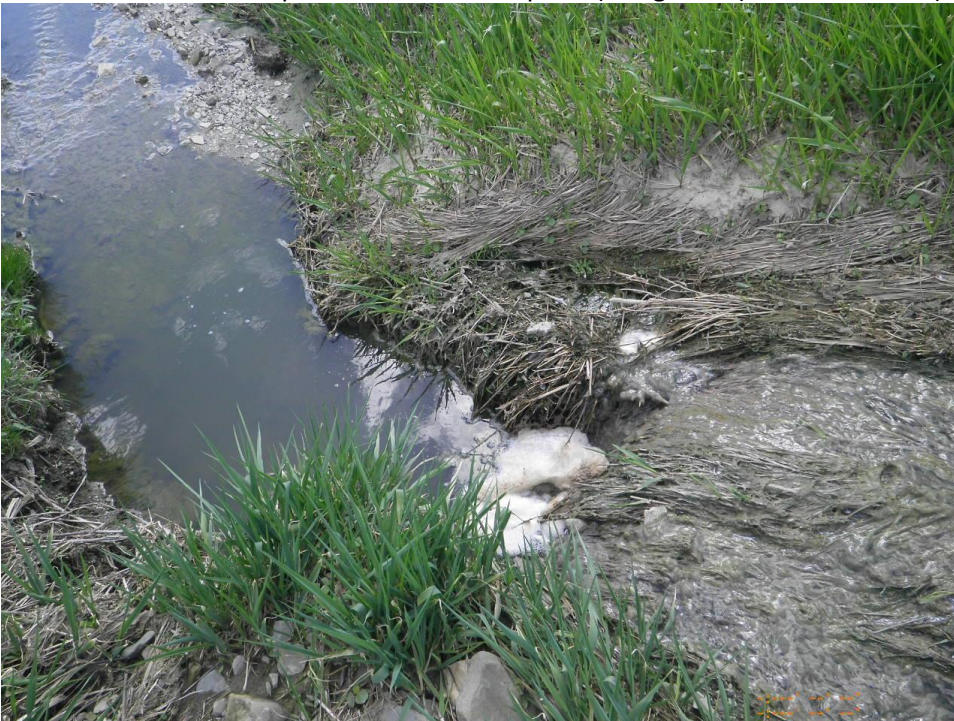
Photo #8 – Close-up of inlet point for pond where field ditch connects; note foaming

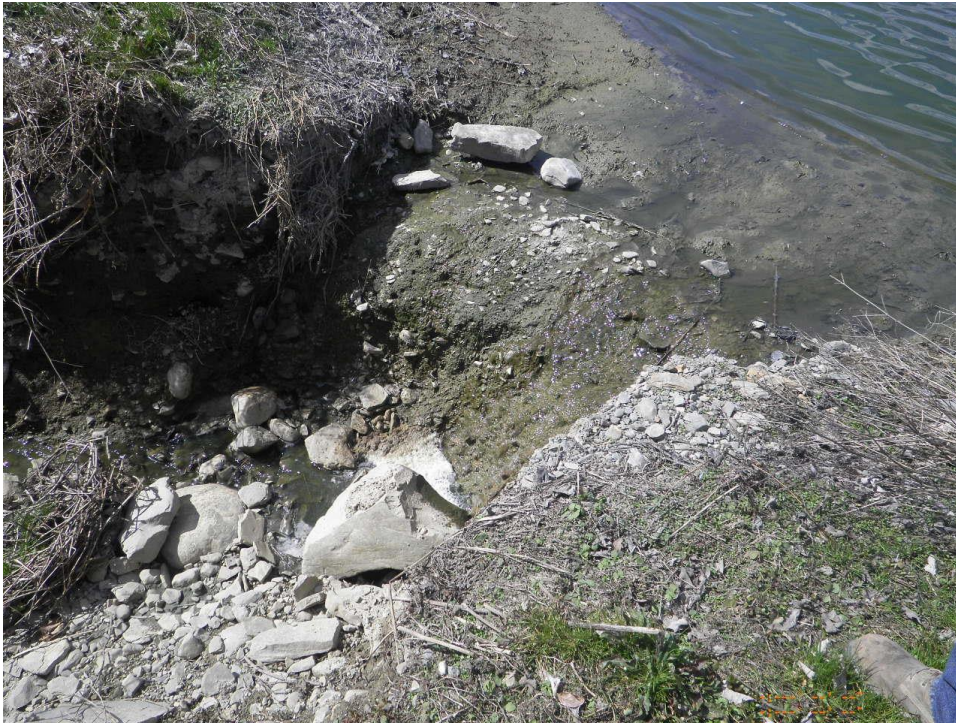
silo. At the pond's outlet point, EPA Inspector Arvizu noted a heavy silage leachate odor and some foaming which indicate the presence of nutrients.

Photo #9 – Close-up of outlet point at farm pond; note foaming

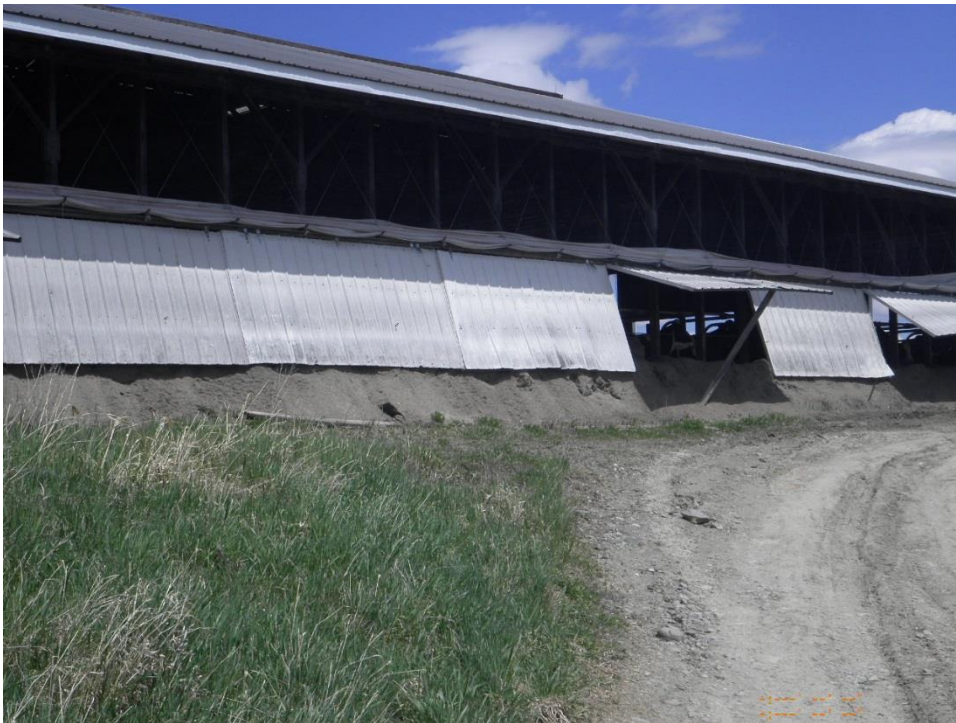
EPA Inspector Arvizu observed bedding around the exterior on the south side of the Milker Barn. Mr. Bergen stated that the bedding consists of shredded paper and it is pushed out by the cows as there is no curb to contain it with the barn. The exterior of the barn is roofed and there is minimal exposure to precipitation. If bedding comes into contact with precipitation, it would run-off to a nearby field.

Photo #10 – Bedding at Milker Barn at Glenview Farm

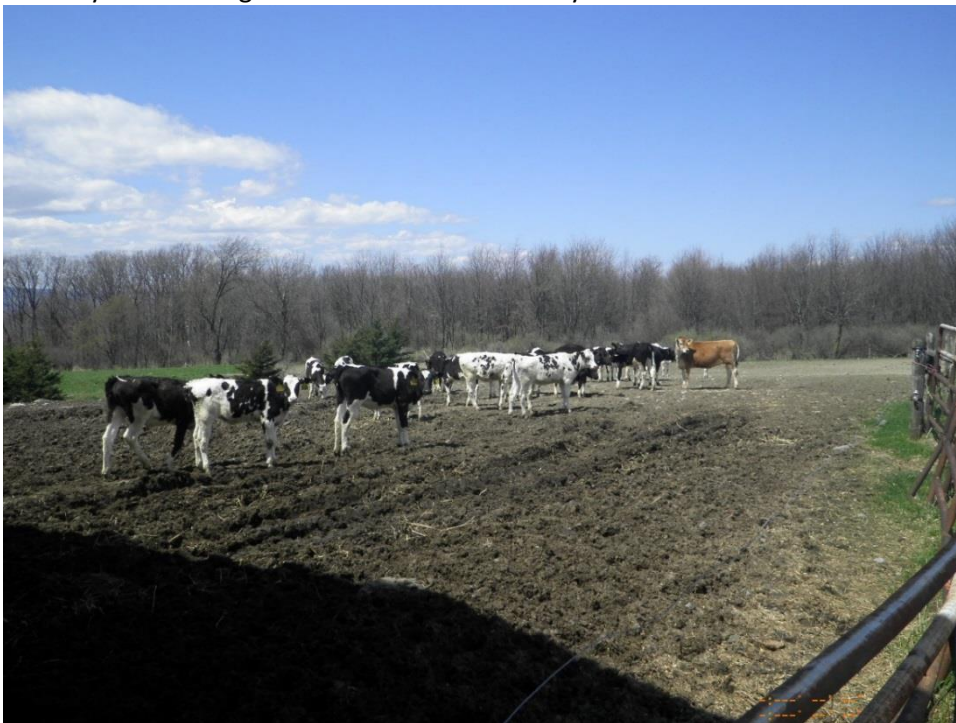
Animals housed within the Yearling Barn have access to a walkway and barnyard which was devoid of vegetation at the time of the inspection making this part of the Facility's production area as defined by the CAFO permit. During the inspection, Ms. Dalrymple and Mr. Murphy discussed the possibility of obtaining funding to develop a laneway and seeding the remainder of the barnyard.

Photo #11 – Yearling Barnyard; note lack of vegetation

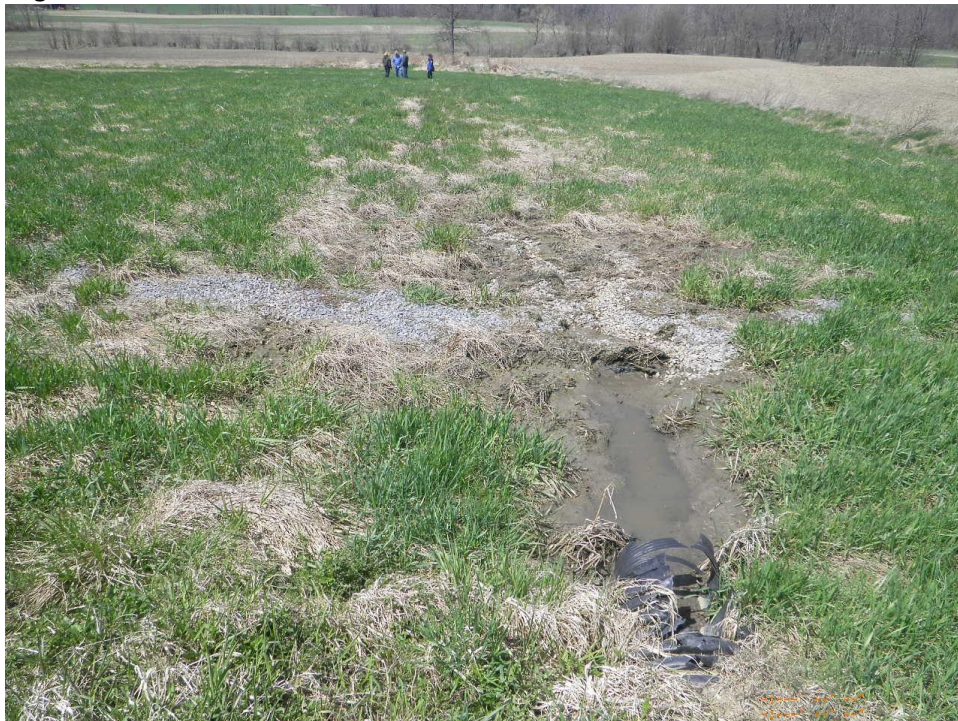
According to the as-built (dated 11/29/2006 from JESS Engineering) provided by the Facility for the VTA, the first of two linked VTAs is 120 feet long, 60 feet wide with a 2 foot berm, and the second VTA is 290 feet long and 100 feet wide. The total surface area of the VTA is 90,000 square feet. At the time of the inspection, the EPA inspection team observed that the level lip spreader at the second VTA was not fully operational due to a blow-out at the top of the first cell. However, the EPA inspection team did not observe kill zones or notable dead vegetation in the VTA.

Photo #12 – Level lip spreader at 2nd VTA; view looking southwest

2. Section X.G of the NYSDEC CAFO General Permit requires the permittee to at all times properly operate and maintain all facilities and systems of treatment and control (and related appurtenances) which are installed or used by the permittee to achieve compliance with this permit. During the inspection, the EPA inspection team observed that the level lip spreader at the second VTA at the Main Farm was not fully operational due to a blow-out.

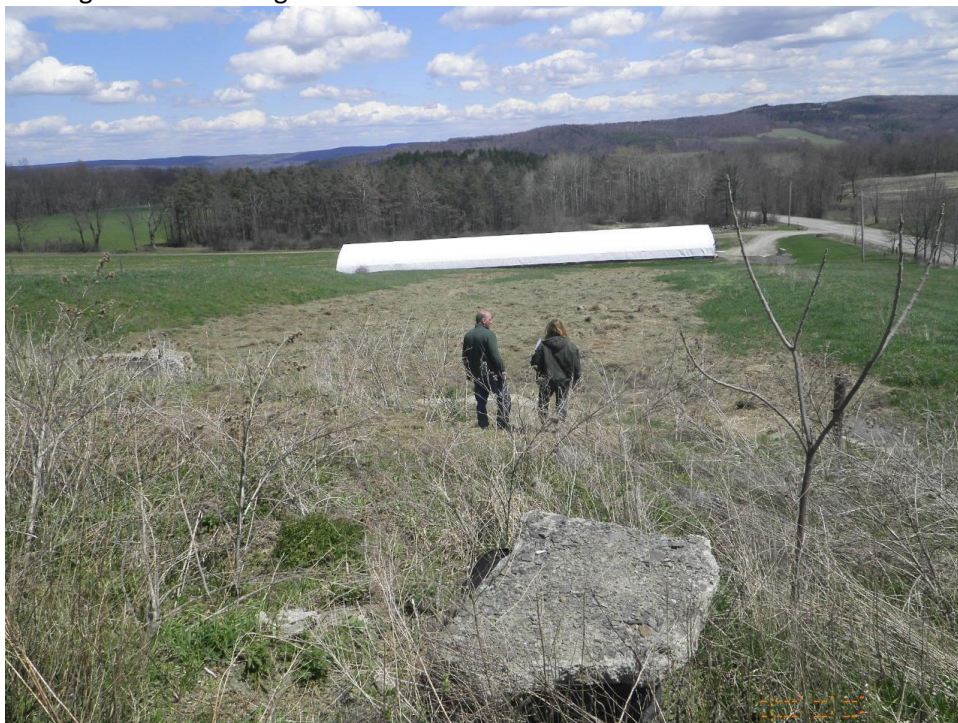
According to the as-built (dated 12/03/2007 from JESS Engineering) provided by the Facility for the VTA, the VTA is 260 feet long and 120 feet wide with a 12% slope. At the time of the inspection, Mr. Bergen explained that during the winter the distribution pipe at the VTA froze and low flow/concentrated flow had discharged to the VTA and flooded the VTA. The Facility had reseeded the VTA and covered it with straw while in the process of waiting for the VTA to germinate and stabilize.

Photo #13 – Glenview Farm VTA; view looking east

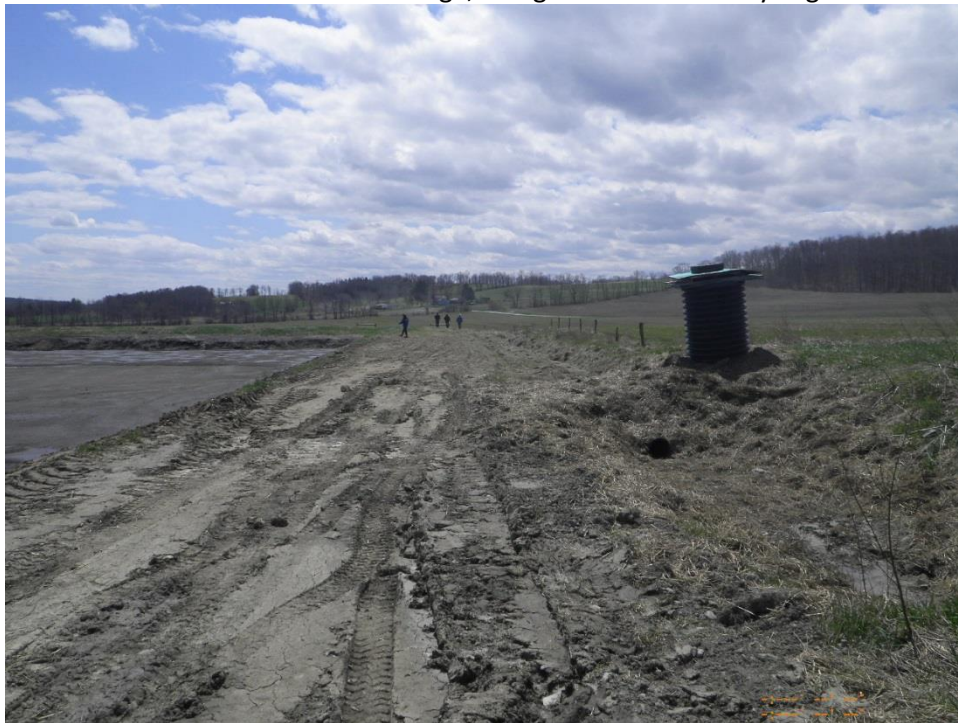
At the time of the inspection, Mr. Bergen stated that the manure level was approximately half full. The EPA inspection team observed that there was partial fencing around the storage, but fence posts were installed. No warning signs were posted. Mr. Bergen stated that he planned to erect fencing around the storage this summer. Mr. Bergen also explained that he had recently reconstructed and stabilized the clean water diversion around the lagoon. While walking around the perimeter of the storage lagoon, EPA Inspector Arvizu observed lack of vegetation/stabilization on the berm of the storage. In addition, EPA Inspector Arvizu observed rodent holes on the south and east sides of the storage, along with minor woody vegetation on the east side of the storage.

Photo #14 – West side of Glenview lagoon; note lack of vegetation on berm

3. Section X.G of the NYSDEC CAFO General Permit requires the permittee to at all times properly operate and maintain all facilities and systems of treatment and control (and related appurtenances) which are installed or used by the permittee to achieve compliance with this permit. During the inspection, the EPA inspection team observed the lack of vegetation and stabilization on the west side of the Glenview storage lagoon. The EPA inspection team also observed rodent holes on the south and east side of the storage. In addition, the EPA inspection team observed minor woody vegetation growth on the east side of the Glenview storage lagoon and the west side of the Culver Road satellite storage.

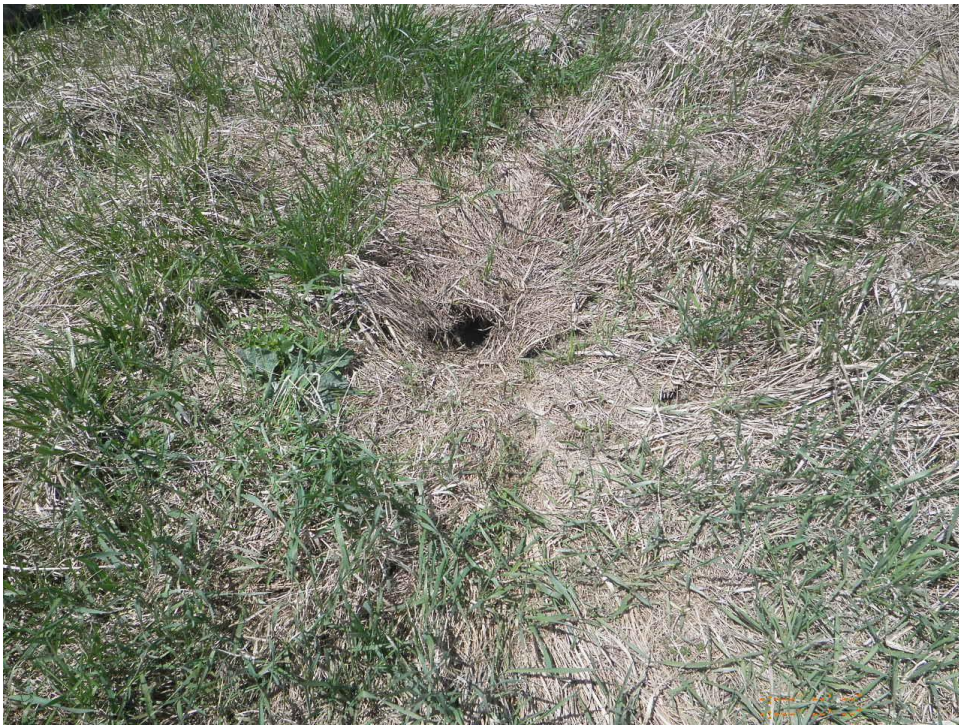
Photo #15 – Rodent hole on south side of Glenview lagoon

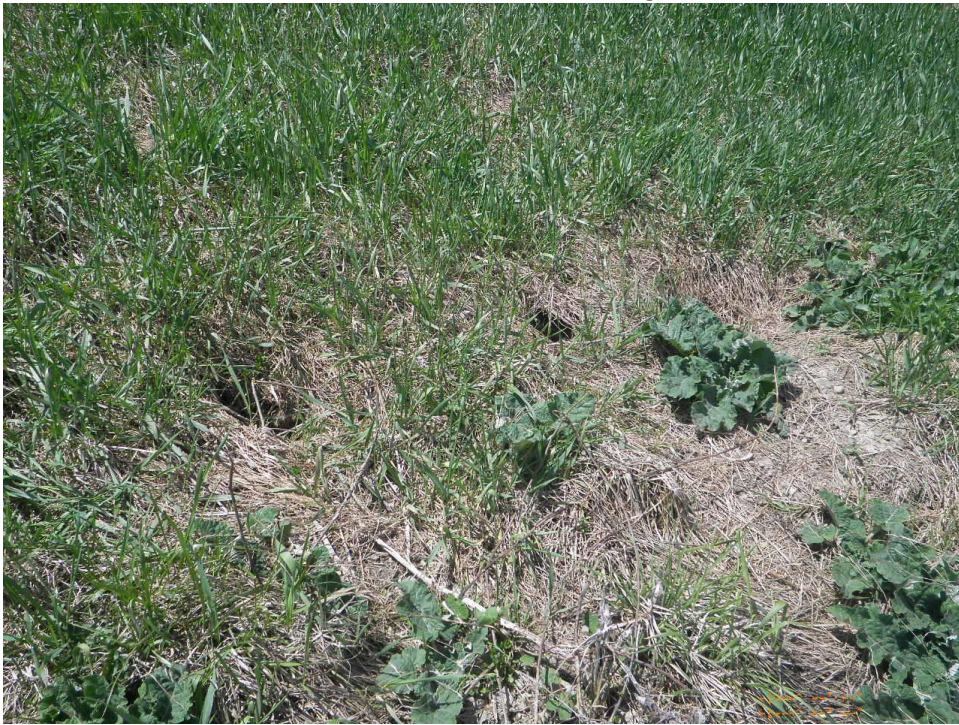
Photo #16 – Rodent holes on east side of Glenview lagoon

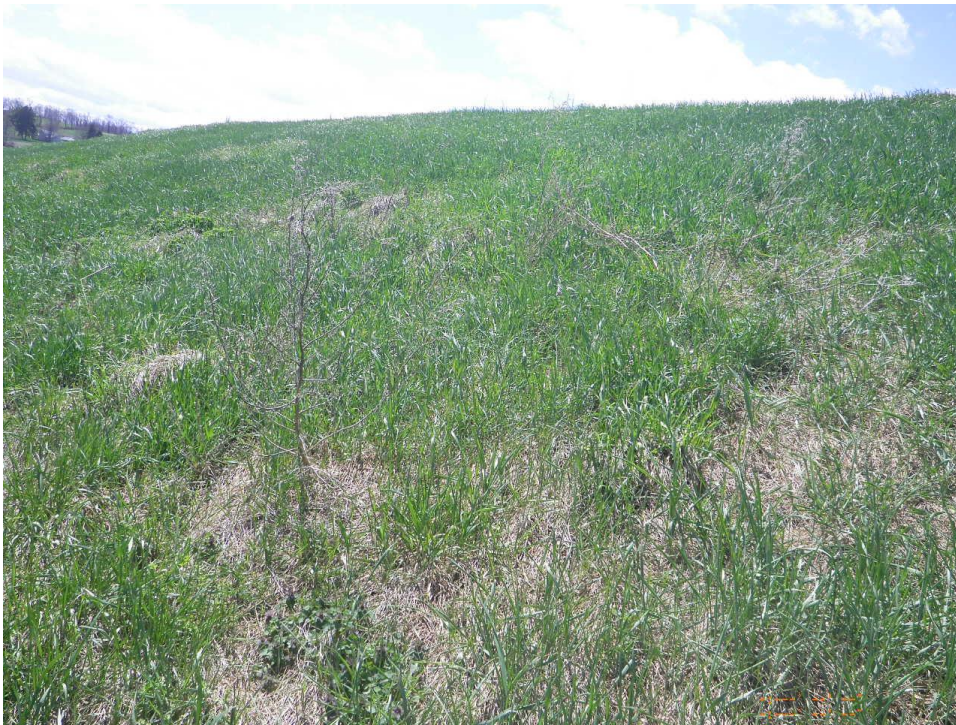
Photo #17 – Minor woody vegetation on east side of Glenview lagoon

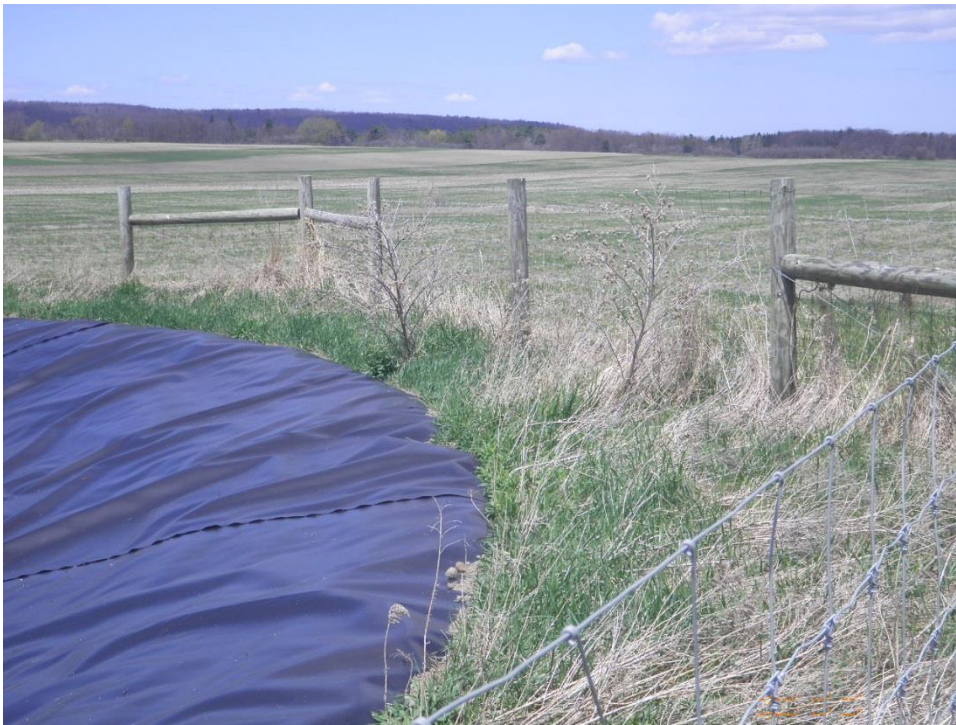
At the time of the inspection, visual observations at the Culver Satellite Storage indicated that the storage was approximately 10 feet deep. The EPA inspection team observed the storage was fenced and warning signs were posted around the storage. Some minor overgrown woody vegetation on the west side of the storage near the plastic lining was also observed.

Photo #18 – Woody vegetation on Culver Road Satellite Storage berm

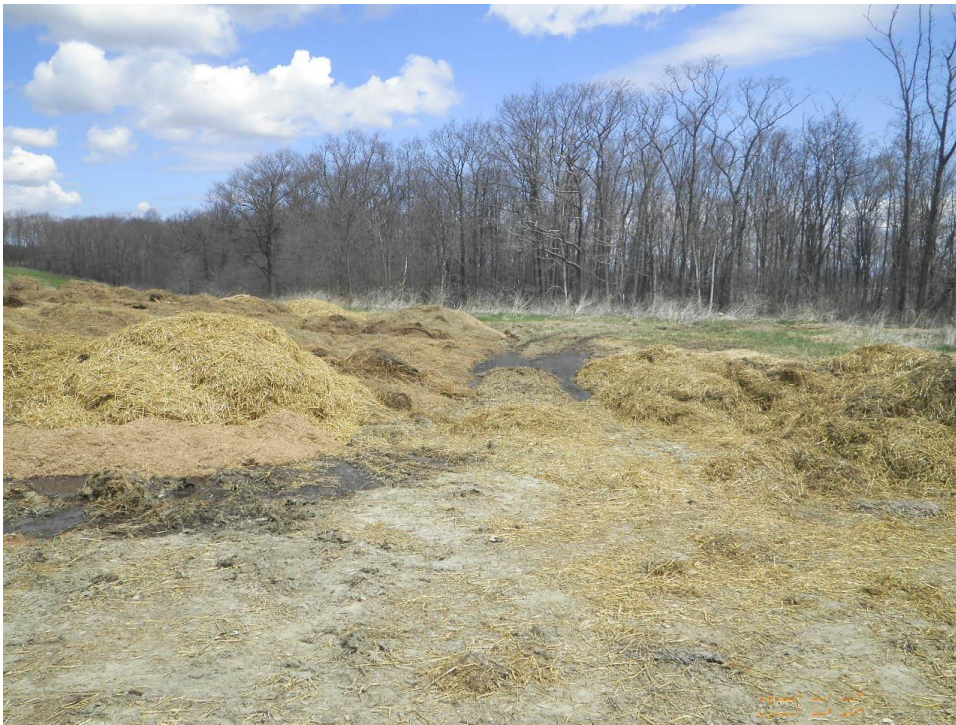
The EPA inspection team observed leachate ponding at the mortality compost pile at the Main Farm. No leachate ponding or O&M issues were observed at the mortality compost pile at the Glenview Farm.

Photo #19 – Mortality compost piles at Main Farm; note leachate ponding in background and lack of wood chip base or covering material

5. Section X.G of the NYSDEC CAFO General Permit requires the permittee to at all times properly operate and maintain all facilities and systems of treatment and control (and related appurtenances) which are installed or used by the permittee to achieve compliance with this permit. During the inspection, the EPA inspection team observed that the mortality compost piles at the Main Farm were not being operated and maintained in accordance with the procedures outlined in the Facility’s NMP. Specifically, the NMP stated that mortalities should be composted following the Cornell Animal Mortality Composting guidelines which call for 2 feet of wood chip base with wood chip and waste feed covering materials. The EPA inspection team observed that the mortality compost piles did not have a wood chip base or use wood chips as a covering material. In addition, leachate ponding was observed around the piles at the Main Farm.
